Automated aircraft repair closer to reality

Inspection and Repair Preparation Cell (IRPC) unveiled, revealing progress made toward automated aircraft repair workcells.

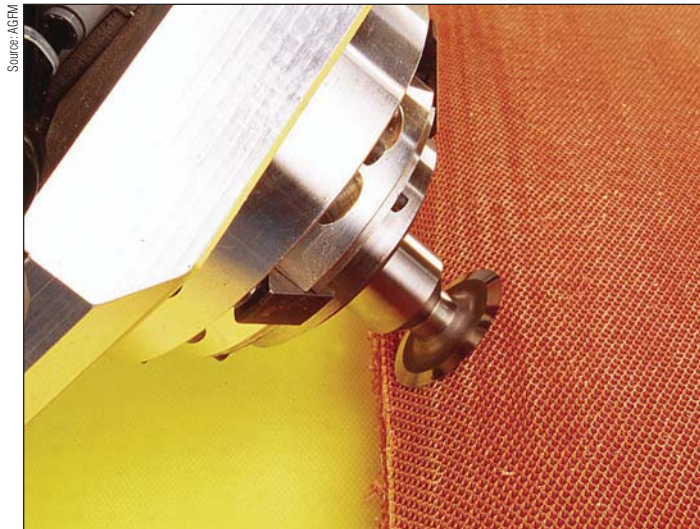
Source: AGFM
Six-axis ultrasonic cutter incorporates a disc to sculpt honeycomb air foil shape.

Cutting will be accomplished with a 6-axis ultrasonic cutting and routing machine, outfitted with new carbide knife cutter tools that are able to make fewer, deeper cuts, resulting in less tool wear and fewer tool changeouts. After the damaged area is removed, patch material, including core, will be cut to match the shape exactly.

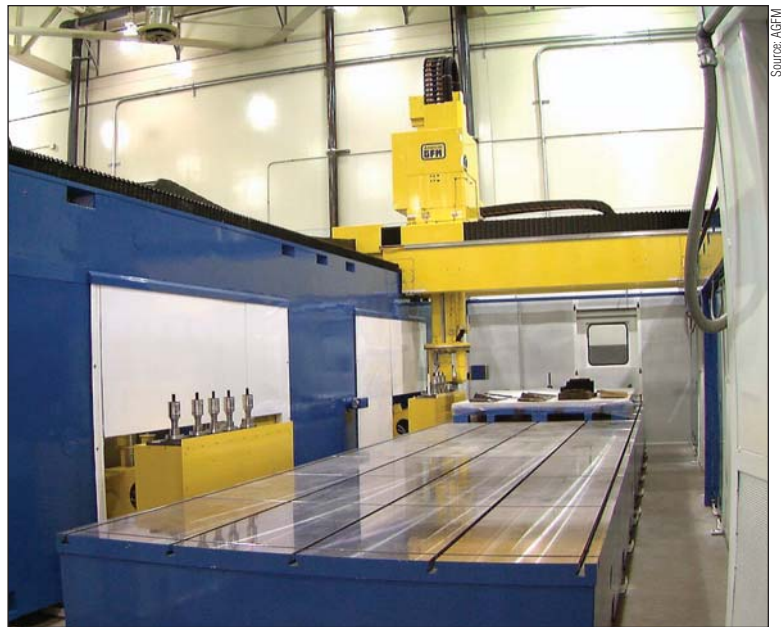
AGFM Model RMT50, which can be configured with all "IRPC" technologies for a complete cell.

The GFM organization's role in IRPC is to provide a CNC machining center that not only can cut the damaged material from the part but also can cut new repair plies and core on the fly. An integral part of the AGFM cutting system is laser projection capability, provided by Assembly Guidance Systems Inc. (Chelmsford, Mass.). Integrated laser-guided kitting and automated ply verification capability, developed by Assembly Guidance, are integral parts of the AGFM cutting systems, says Scott Blake, president of Assembly Guidance. A
